Products Review

and SERVICE NEWS

DECEMBER, 1946

PRODUCT SERVICE

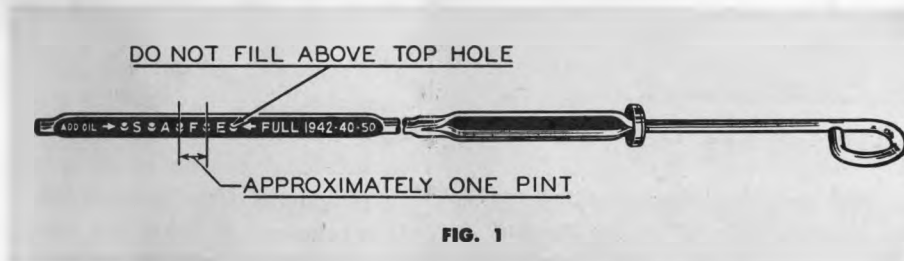
FIG. 1

There has been some comment regarding the oil gauge rod, Fig. 1, on the above models being read incorrectly. In some instances the distance between the holes on the rod has been taken to represent one (1) quart of oil. As this distance actually represents approximately 1 pint, shown in Fig. 1, the addition of 1 quart would raise the oil level above the "Full" mark. This excessive oil is burned off rapidly, presenting a false oil consumption.

termining the oil level and not to measure the amount necessary in refilling.

When checking the oil level, the engine should be allowed to stand with the ignition off, for a minimum of two minutes. This allows the oil to flow from the upper engine to the crankcase which will give a more accurate reading of the oil level.

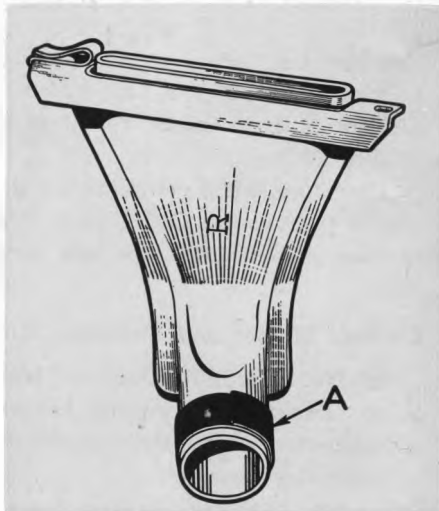
FIG. 1

The right or left inlets can be identified by the letter "R" or "L" on the front of the inlet, Fig. 1.

Before installing any defroster inlets, it is advisable to check the fit of the defroster hose on the inlets. If the hose does not fit tight enough to eliminate the possibility of its

slipping off, the opening can be expanded to give the required fit. As an alternative for inlets already installed, a piece of friction tape wound around the inlet, as shown at "A" Fig. 1, will provide a snug fit.

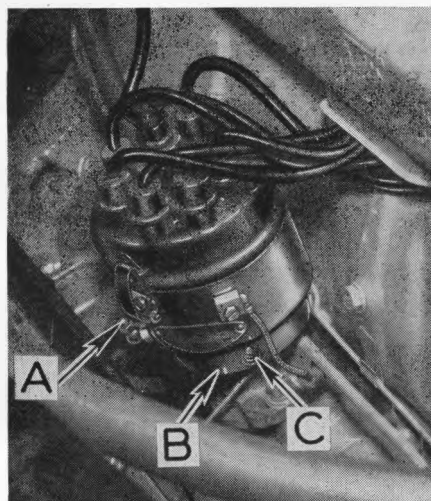
FIG. 1

In order to prevent premature wear or possible seizure of the distributor shaft, it should be properly lubricated at all times. It is common practice to force lubricant (wheel bearing grease) through the fitting, "A" Fig. 1, at the side of the hous-

ing "B" until the lubricant flows out the overflow hole "C" in the housing. In some cases a small amount of lubricant may flow from the hole even though the lubricant reservoir is not completely filled.

This will occur if the overflow hole should be blocked with a small amount of lubricant which is forced out by the trapped air being expelled as the new lubricant enters the reservoir. To make certain that the reservoir is completely filled continue to force lubricant through the fitting until it flows out the overflow hole in a continuous stream.

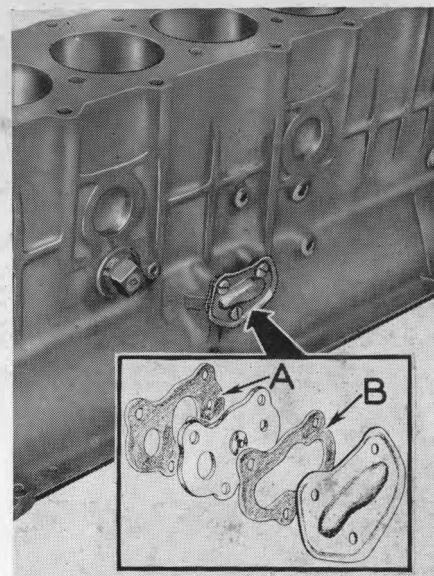
FIG. 1

If the two oil distributor gaskets, "A" and "B" Fig. 1, are interchanged on the above models, it will result in low pressure registering on the gauge when the engine is idling.

When checking complaints of low oil pressure (indicator barely off pin) with the engine idling on new cars or rebuilt engines, check the oil distributor gaskets and make sure they are located as shown in Fig. 1.

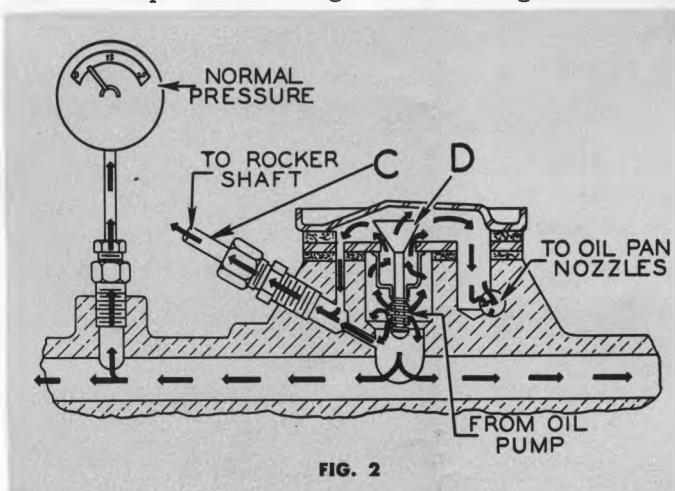
FIG. 2

The path of oil through the distributor is shown in Fig. 2, with the gaskets in their correct location. As can be seen, oil from the pump enters the oil distributor where it is directed into the main gallery to feed the main and camshaft bearings, also through the pipe "C" to the valve rocker arm shaft. It is applied against the oil distributor valve "D" and must build up to a pressure of 6 lbs. before the valve will open to allow oil to pass to the troughs in the

oil pan. The gauge connected into the oil gallery registers the pressure in the system.

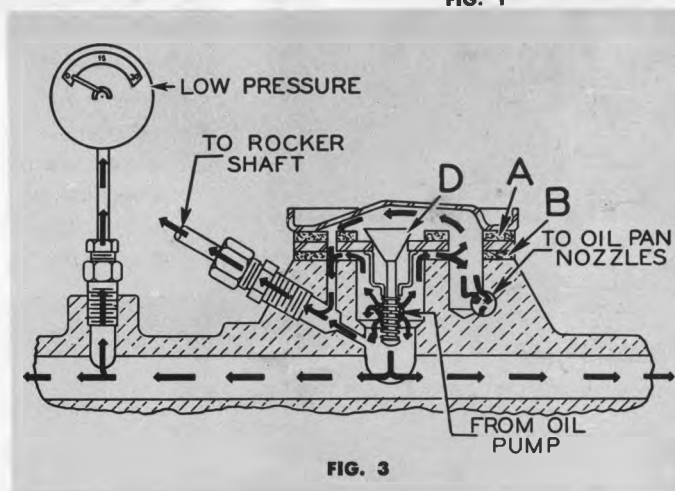
FIG. 3

If gasket "B" is substituted for gasket "A", as shown in Fig. 3, oil by-passes the valve "D" and flows directly to the troughs in the oil pan. Thus there is no restriction to build up pressure in the system when the engine is idling and the oil gauge hand hardly moves off the pin.

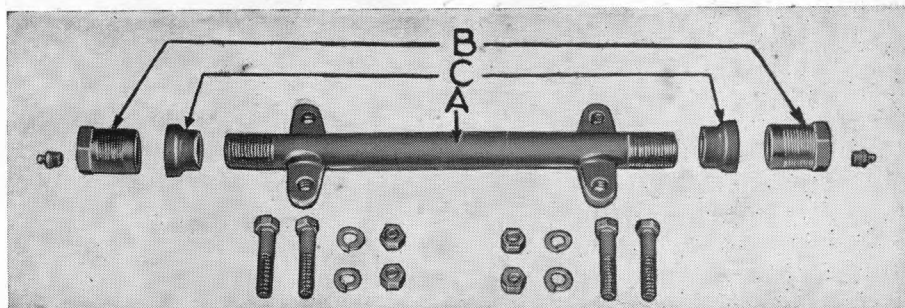
FIG. 1

The knee action lower control arm shaft, "A" Fig 1, has now been released for the models mentioned; also steel bushings "B" can be substituted for the original composition bushings. This will make it possible to service a large percentage of the lower control arms on these cars without the necessity of replacing the assembly. Complete lower control arm assemblies will still be

available, however, under the same Part Numbers, to take care of cases where the control arms or spring seat are badly damaged due to the car having been in an accident.

Lower Control Arm Package No. 1393367 contains the parts necessary to service one lower control arm, and consists of the following:

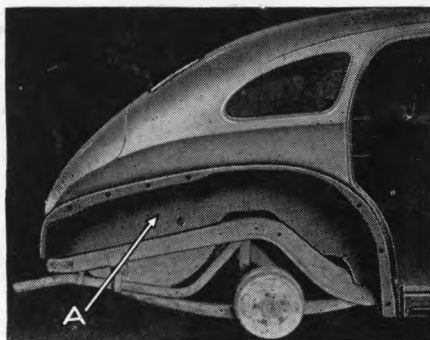
Fig. 1

Normally, when a rear wheelhousing, "A" Fig. 1, is damaged, the complete rear quarter side outer panel, shown in Fig. 2, has to be

replaced because the wheelhousing is not serviced separately.

Experience has proven that a damaged rear wheelhousing can be removed and only the wheelhouse section of a rear quarter panel in-

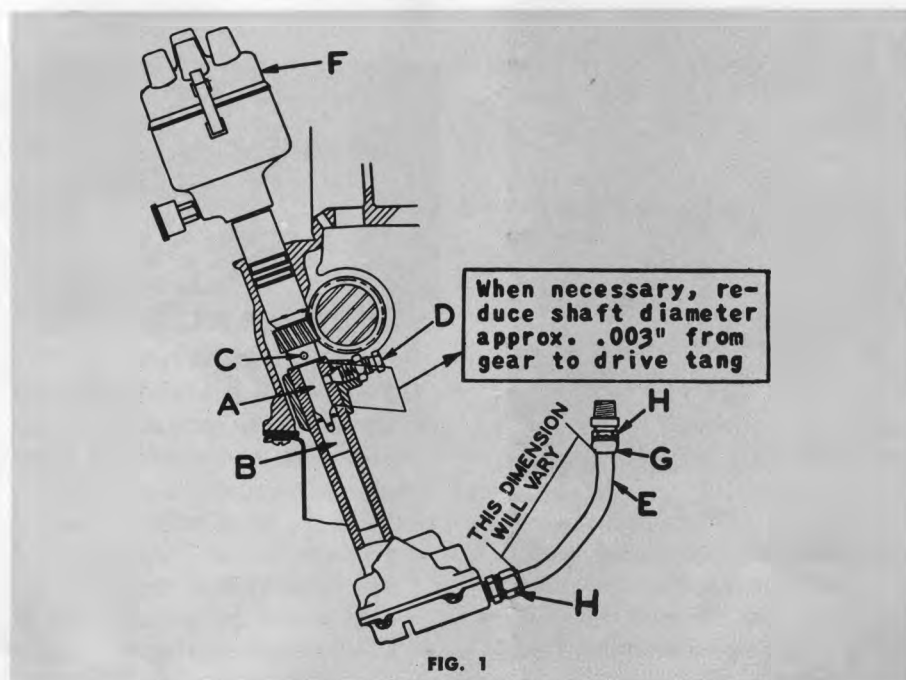
FIG. 1

Misalignment between the ignition distributor shaft, "A" Fig. 1, and the oil pump shaft "B" may result in the seizure of one or both of these shafts, causing the distributor gear pin "C" to shear. This could occur after the oil pump had been removed and re-installed for any reason.

1. Remove the camshaft.
2. Install the ignition distributor and the oil pump retaining screw "D". Do not connect the oil line "E".
3. Remove the distributor cap "F" and rotate the distributor shaft to see that there is no binding of

tributor and reduce the diameter of that part of the distributor shaft located between the drive gear and the drive tang approximately .003" (standard shaft diameter .4895" — .4900") as referred to in Fig. 1, then re-assemble and re-check for free rotation.

4. Install a new delivery pipe "E" No. 839203 along with new coupling sleeves "G" No. 120430 and nuts "H" No. 140290.

Caution:—A new oil delivery pipe is necessary as the dimension between the pump outlet and the connection at the cylinder block will vary on different jobs.
